Milton Somers House
CH-714
LaPlata
Private

Maryland Inventory of Historic Properties Form

Inventory No. CH-714

historic Milton Somers House
other

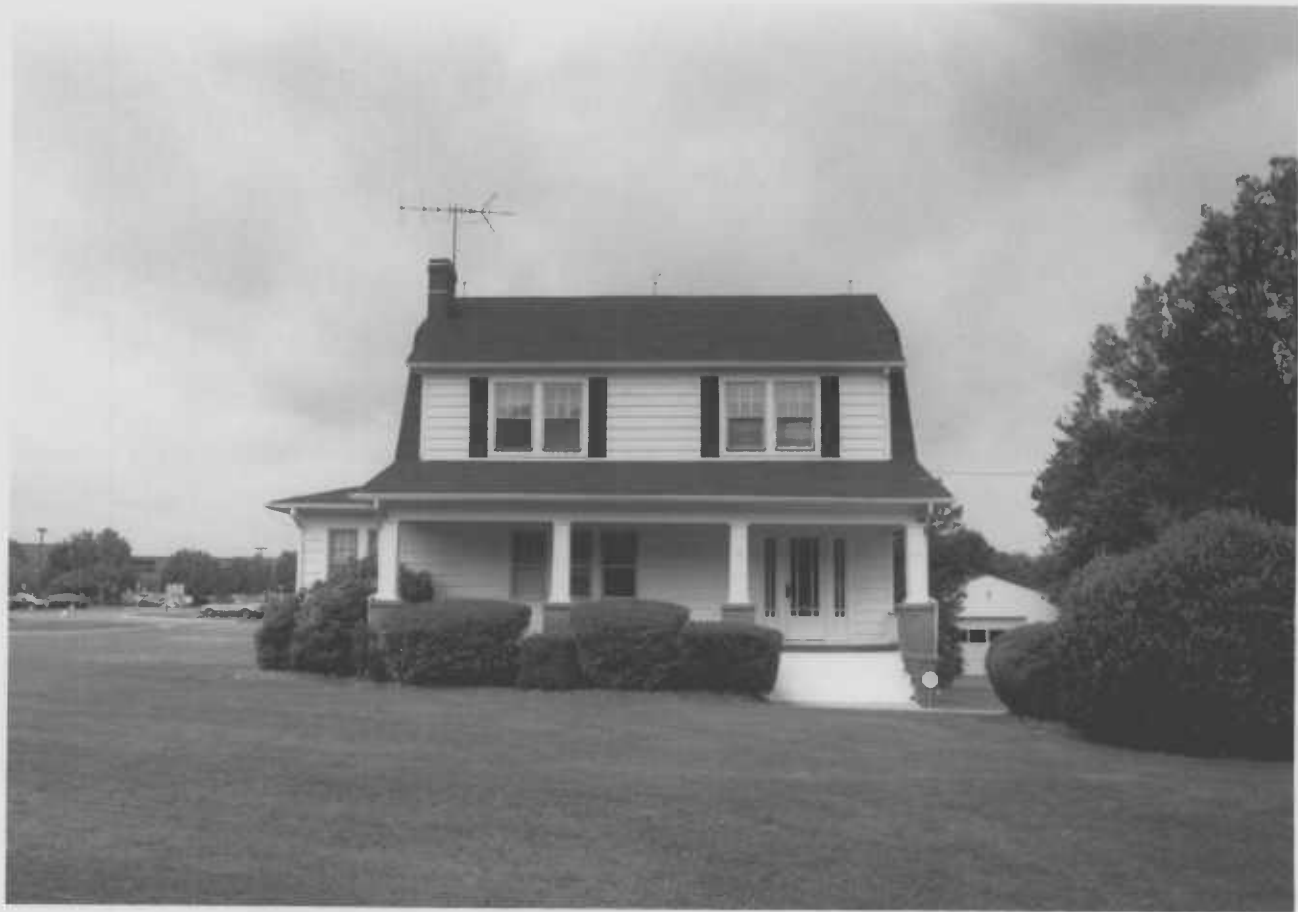
1 OF 7

The Somers House had a wooden frame sheathed with weartherboard siding and asphalt shingles. The foundation was concrete and concrete block The front elevation includes an entry porch supported by thick, square wooden columns resting on brick piers. A grouping of three 6/1 windows was situated nearest the south corner. The second floor has two symmetrical pairs of 6/1 windows occupying the dormer.

MD SHPO
LOOKING W

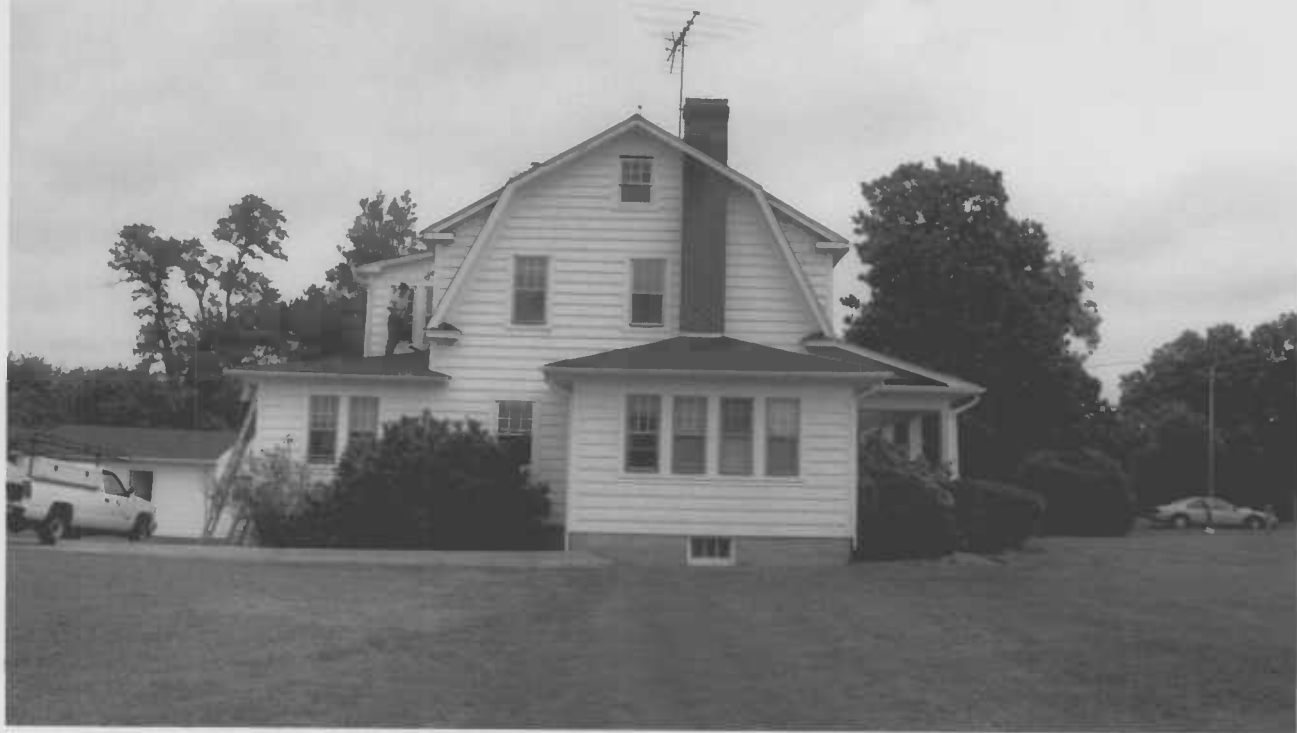
2 of 7

The south elevation had single, centered 6/1 window in the attic story above two asymmetrical 6/1 windows in the second story. The first floor is obscured by a one story wing which may have been original to the dwelling. This wing consisted of a rectangular room covered with a hipped roof. It was lighted by two narrow 6/1 windows on the front elevation and four 6/1 windows on the south elevation. A 6/1 window is visible on the main wall.

SOUTH ELEVATION

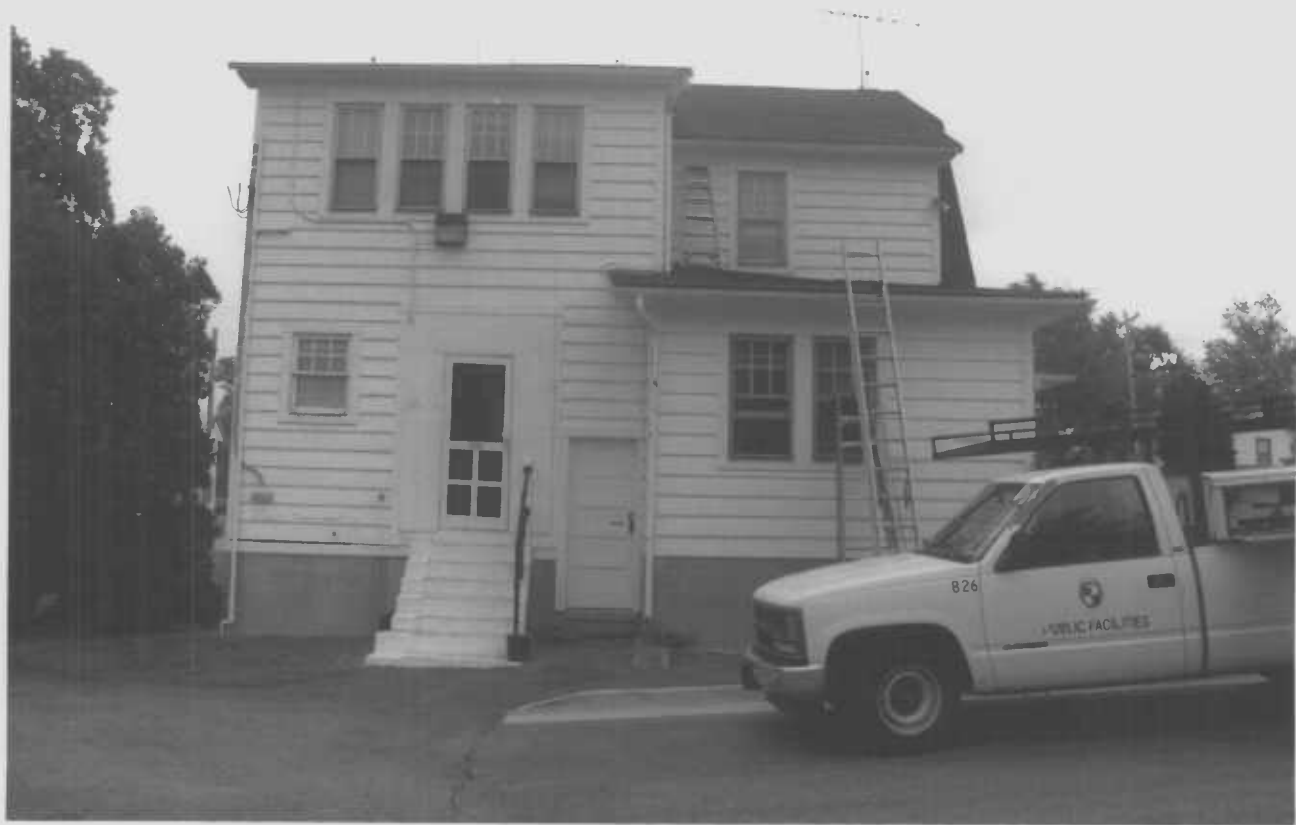
3 of 7

The rear elevation included two extensions from the original form including a two story ell projecting from the northernmost bay and a one story hipped roof in the southernmost bay. The larger of the two includes a row of four narrow 6/1 windows on the second floor above a small 6/1 window on the first floor next to an altered doorway which is approached by a steep set of stairs. A 5-panel door closer to ground level stood at the interior end of this bay. The second story southernmost bay of the main structure includes a single 6/1 window. The one story addition below held a pair of 6/1 windows.

WEST ELEVATION

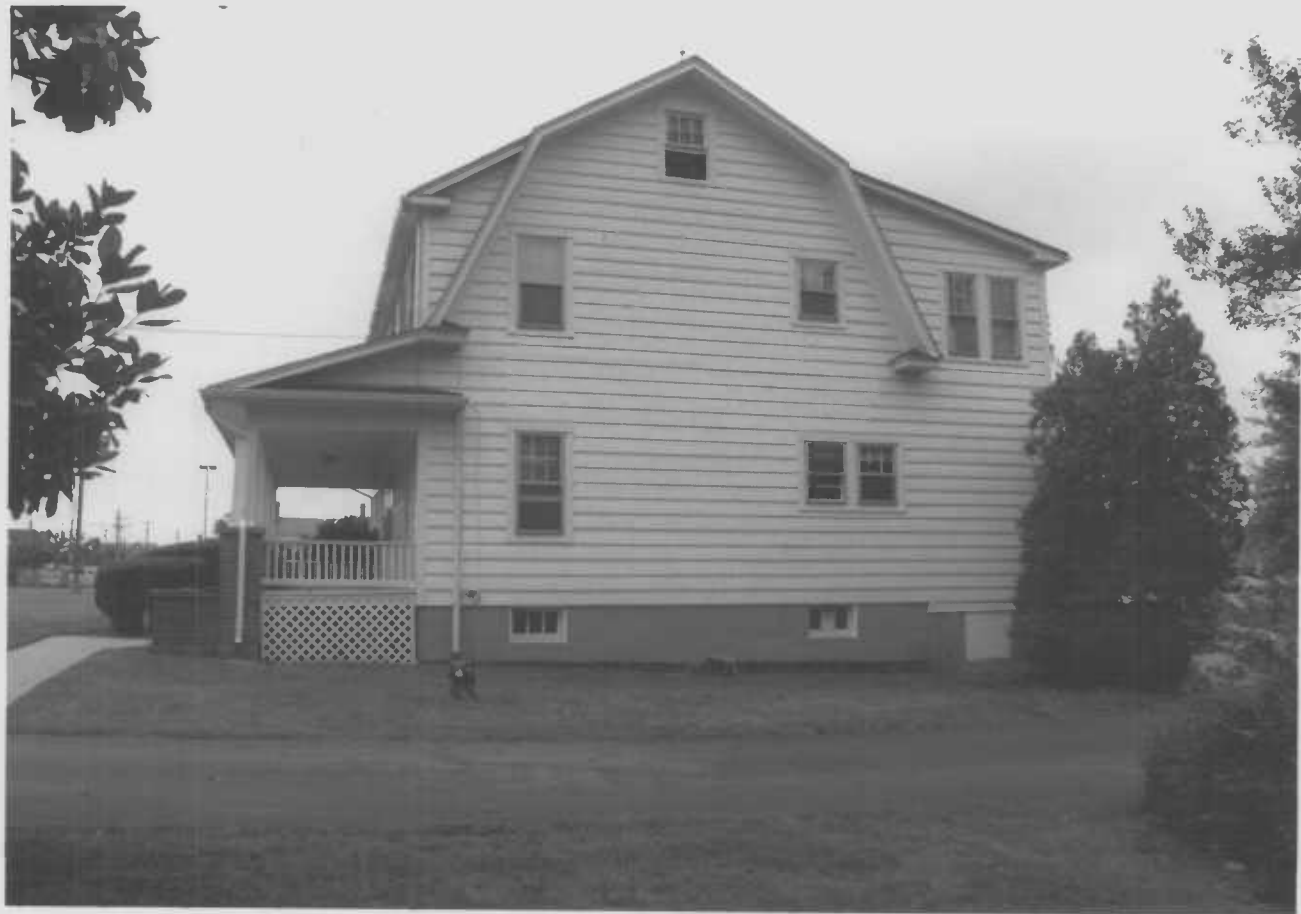
4/257

The attic story of the north wall includes a single 6/1 window. The second story had a full size 6/1 window near the front elevation and a smaller 6/1 window toward The rear where a second story bathroom is houses. The first floor has a 6/1 window near the façade which lights an interior stair passage and a pair of smaller 6/1 windows which lit the kitchen. The second story rear shed addition included a narrow pair of 6/1 windows.

NORTH ELEVATION

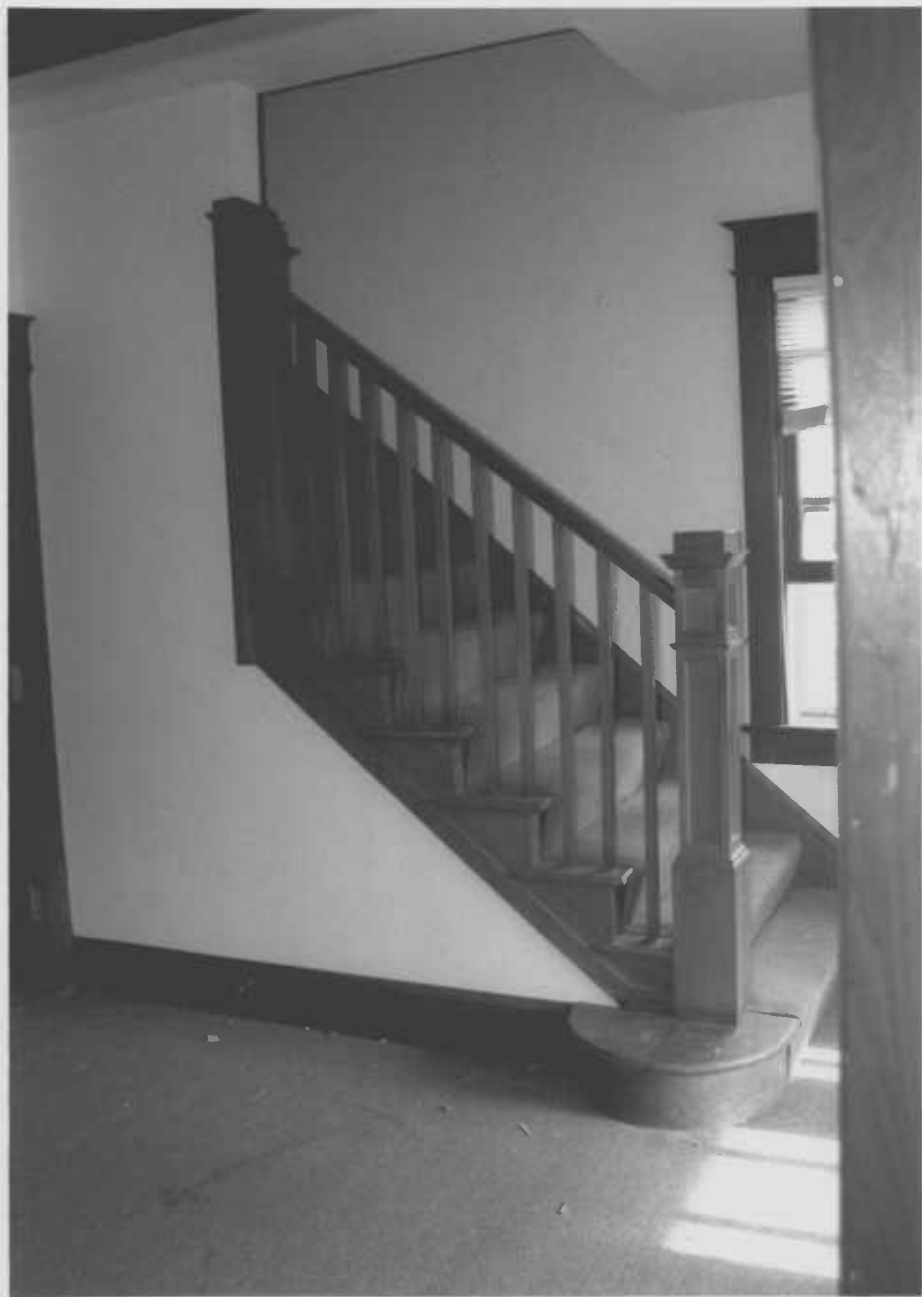
CH-714
Milton Somers House
Charles Co. Md.
C. Currey
812001
MD SHPO
STAIR, LOOKING N
5 of 7

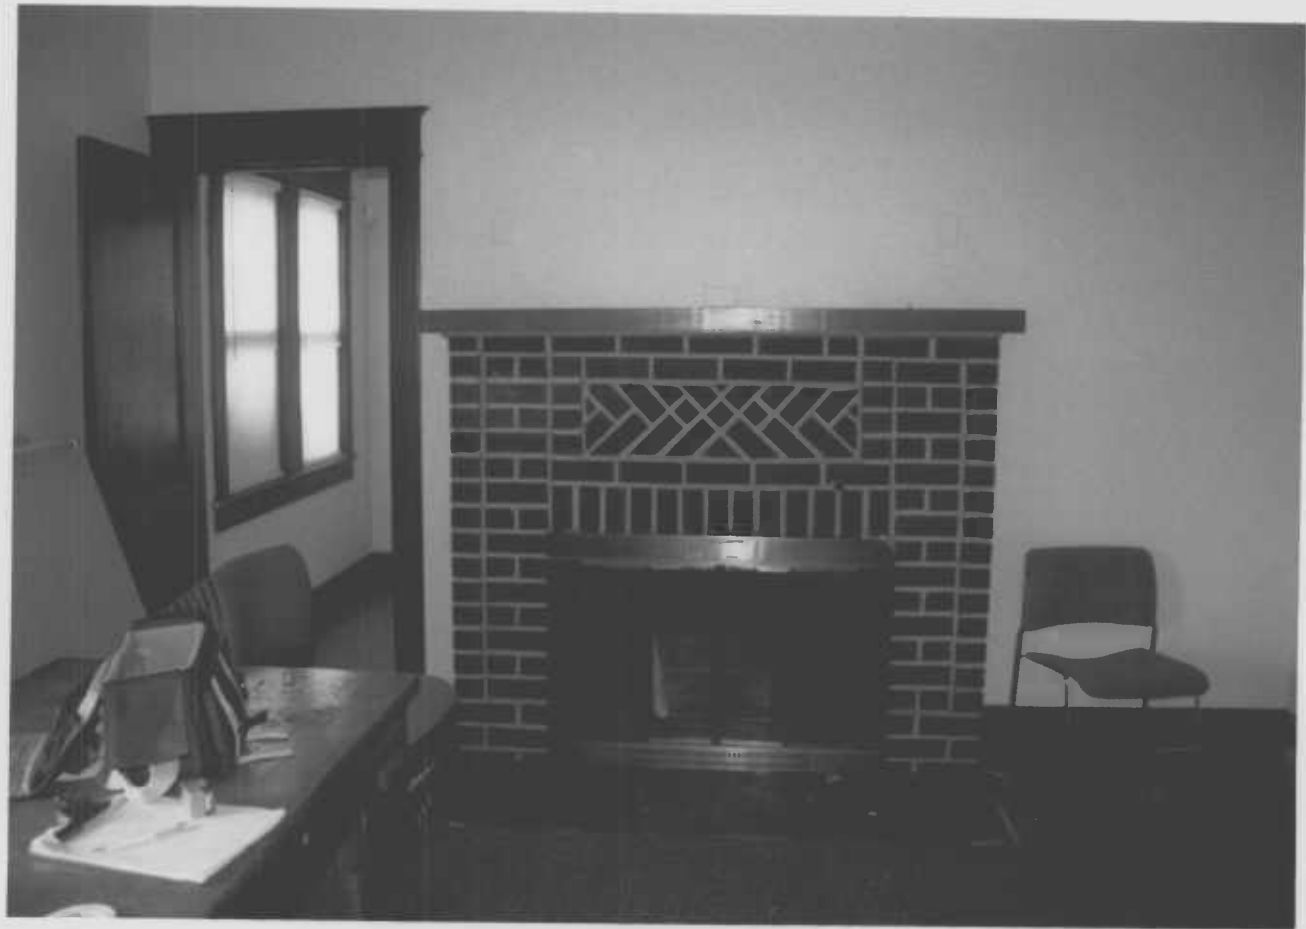
6 of 7

MANTLE, LOOKING S

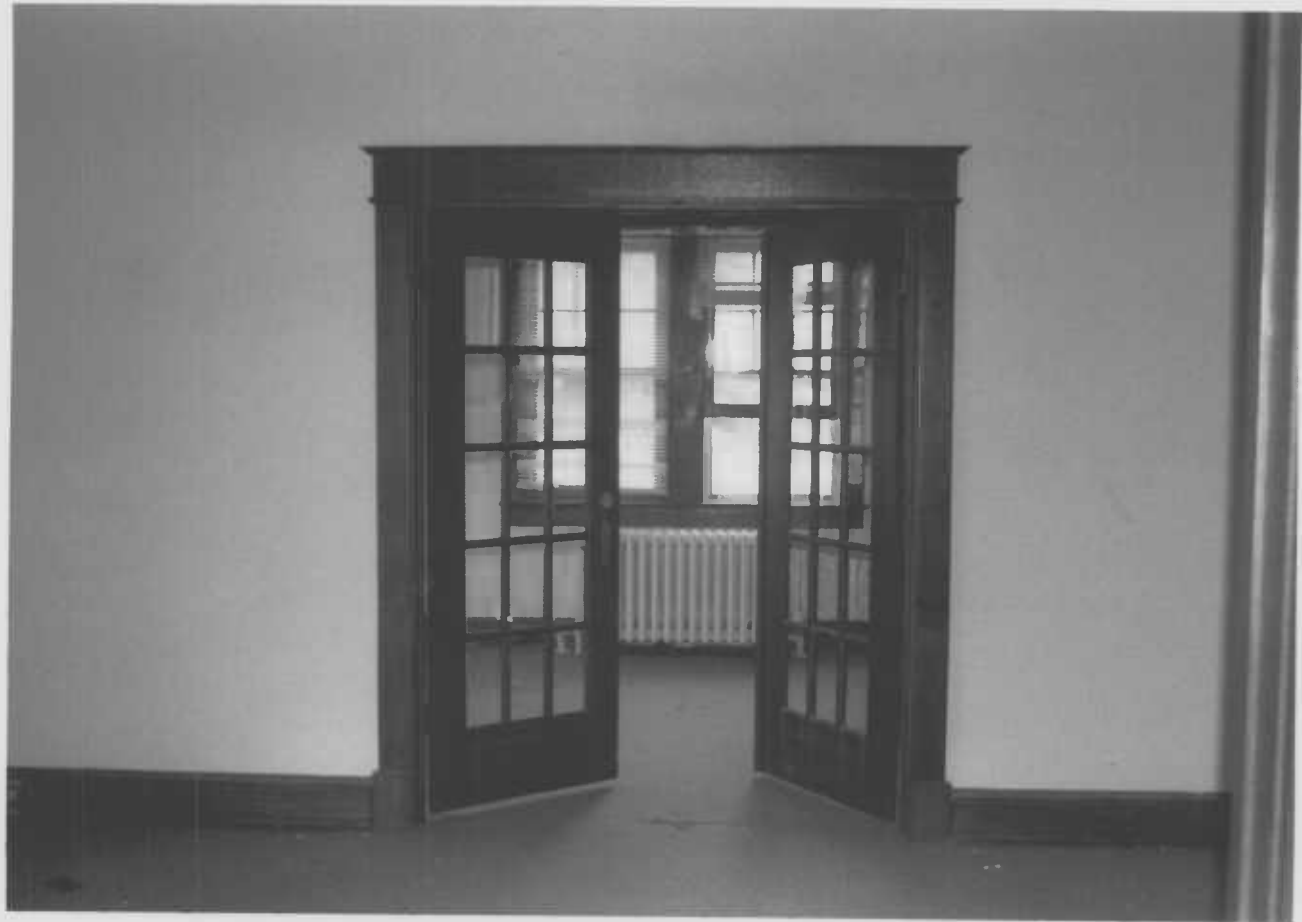
7 OF 7

LOOKING W FROM DINING ROOM
